GEORGIA FOUNTAIN COMPANY, INC.
2513 Royal Place
Tucker, GA 30084 USA

TECH LETTER 08/2014: The Subject of Bonding

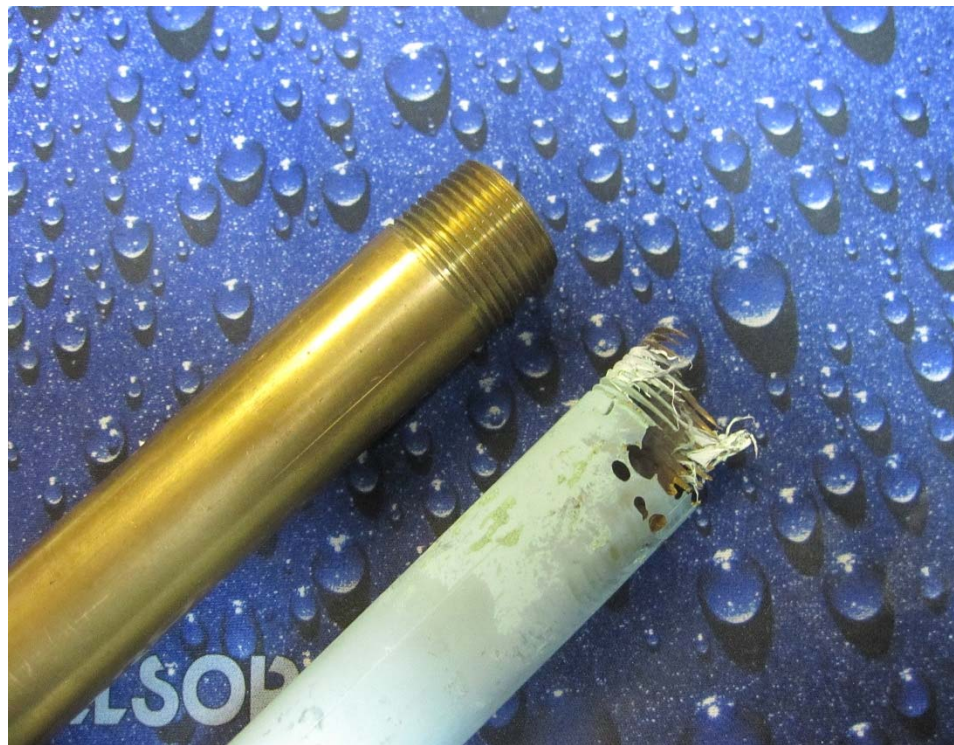
In the picture below you see a new piece of SCH40 red brass water pipe side by side with a like type piece removed from one of the projects not done by Georgia Fountain Company, Inc.

One can see the

TOTAL DESTRUCTION

of a similar piece of SCH40 red brass piping in the small time span of 4 years.

Dissimilar metals in the same body of water will have electrolytic convection between the different metal parts just like in a car battery. This activity is prevented when the required bonding system is installed per code The absence of the

bonding system is evident by the copper oxide (green colored deposit on the destroyed brass pipe) most likely traveling to another metal pipe part in the system indicating the copper departing the brass by galvanic actions.

The project was inspected by Georgia Fountain Company and a bonding test was done. It was discovered that of the multiple fountains on the project one fountain system had no bonding system at all and one fountain system had parts of the bonding system omitted. Now the project faces repair costs that not should have to be encountered because of the poor workman ship on the project and most of all because of the non-existing or incomplete inspection by the city or county electrical inspector which, if done diligently and correctly, would have caught this problem before the concrete trucks rolled to the project.

It is vitally important to make sure the supplied drawing details and the national electric code are followed **IN DETAIL** to avoid system failures of a magnitude like this. For additional information or for a HQ picture do contact us directly.
